SMITHVILLE, TENN.
N 3552.5-W 8545.7/7.5
1960
PHOTO REVISÉ 1979

Landslides and related features interpreted
from aerial photographs:
1:40,000 (Black and White) 1979
1:79,000 (Black and White) 1976

Photointerpretation and field check 1981
This report is preliminary and has not
been reviewed for conformity with U.S.
Geological Survey editorial standards.

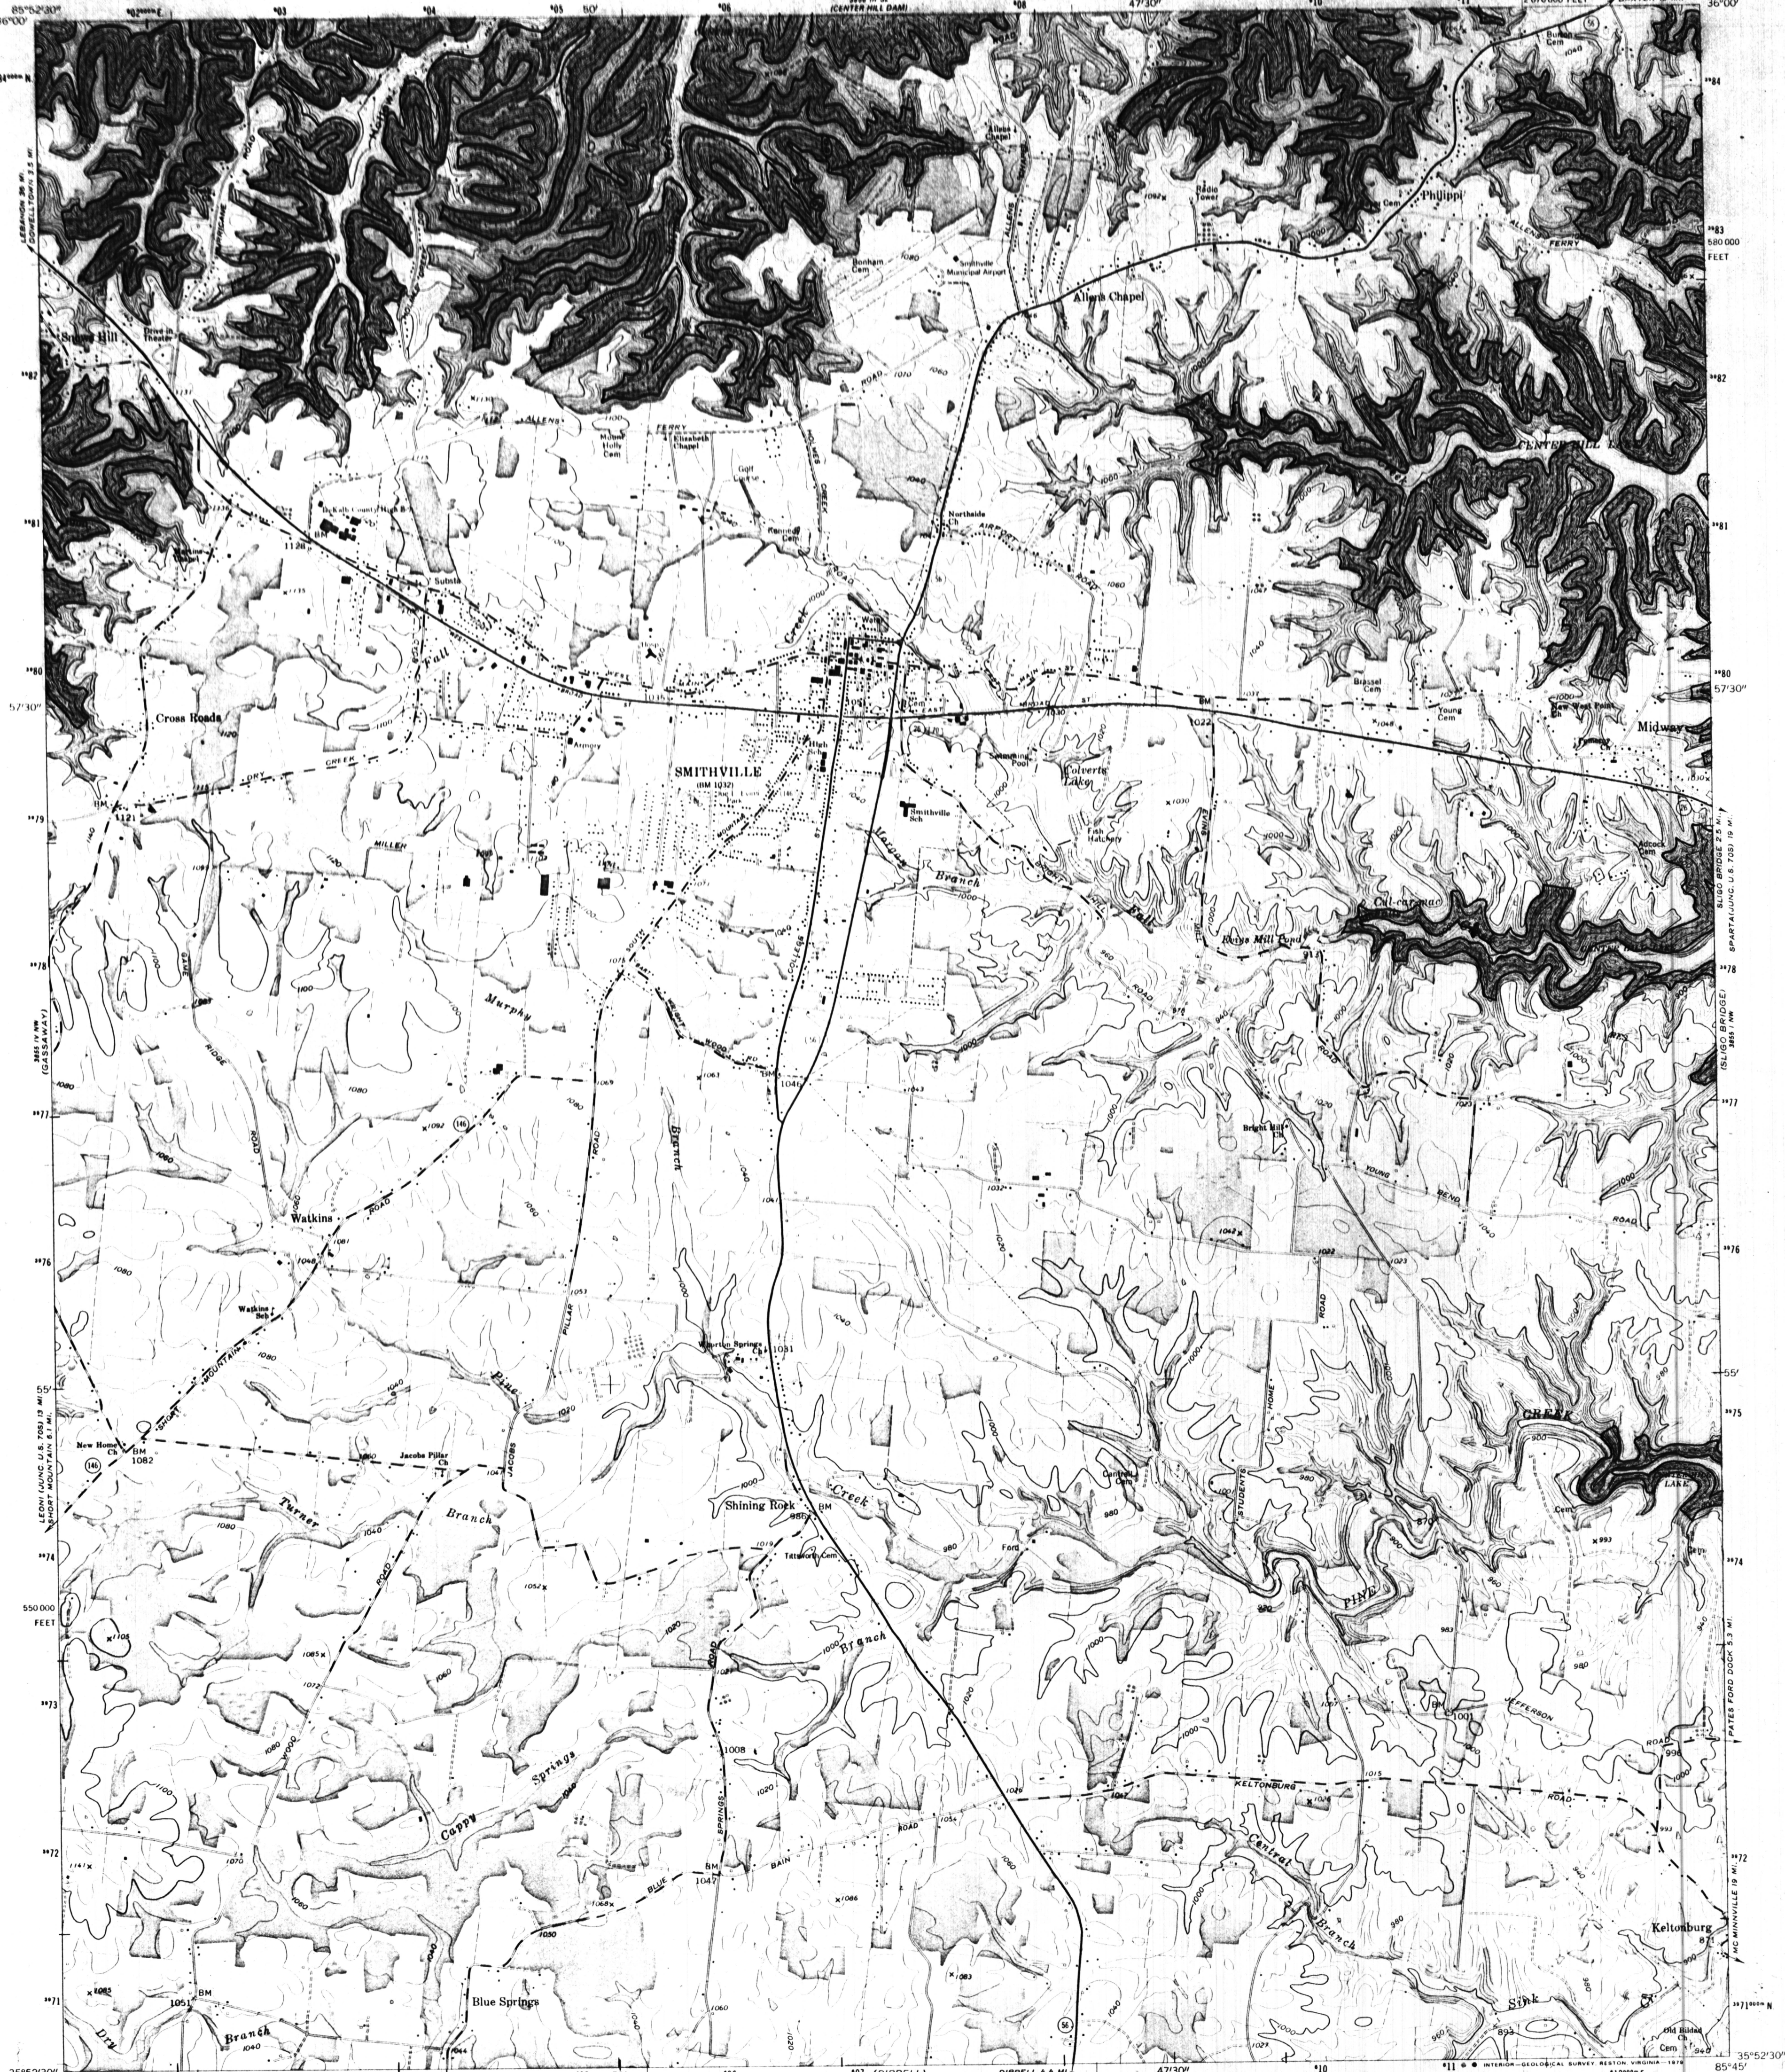
ACTIVE OR RECENTLY ACTIVE LANDSLIDE
Complex landslide composed of earthflow, debris
slide, earth and rock slump. Identified from
historical records, and from scars, debris and
other field evidence. Ground extremely unstable;
sliding accelerated by excavation, loading and
changes in drainage conditions. May include
areas with several active slides too small to
be shown separately. Questioned where doubtful.

OLD LANDSLIDE
Area of extensive hummocky ground caused by
earthflow and earth and rock slump. Lacks
clear evidence of active sliding. Relatively
stable in natural, undisturbed state,
generally not affected by small structures properly
sited in areas away from the edge of the toe;
can be reactivated by extensive, rapid exca-
vation, loading, and changes in ground water and
surface water conditions. Area of old landslide
probably includes recent ones not identified
from field evidence or otherwise documented.
Upslope boundary of landslide generally defined
by modified scarp, but downslope (toe) may be
gradational and not well defined. Questioned
where doubtful.

COMBINATION LANDSLIDE
Area of recent and old slides in which
individual slides are not identified.

COLLUVIAL SLOPE
Valley wall along major streams with slope as
steep as 40 (85%); stony, clayey silt soil up
to 50 ft. (15 m) thick; commonly buttressed by
a terrace or bench at the toe of the slope; very
susceptible to sliding by cutting of toe area,
removal of terrace or bench, and overloading;
slide commonly activated without apparent cause.

COLLUVIAL SLOPES WITH LANDSLIDES
Landslides too small or obscure to map
individually.

**AREAS SUSCEPTIBLE TO DEBRIS FLOWS AND DEBRIS
AVANCHES**
Primarily shallow, narrow ravines and chutes with
accumulation of stony colluvium generally 10 ft.
(3 m) or less in thickness; susceptible to rapid
movement during intense rainfall. Most ravines
and chutes designated show evidence of former
debris flows and avalanches.

AREAS SUSCEPTIBLE TO ROCKFALL
Steep, locally vertical, natural and man-made
slopes and cliffs, 15 ft. (4.5 m) or more high;
formed dominantly of sandstone, limestone, sandy
shale, mudstone and claystone. Interbedded mud-
stone, claystone and shale weather rapidly leaving
sandstone and limestone rock faces unsupported.

SOIL AND ROCK SUSCEPTIBLE TO LANDSLIDING
Soil and rock similar to that involved in land-
slides elsewhere in map area; primarily areas
underlain by claystone, mudstone and shale
associated with other rock types. Rock weathers
rapidly on exposure forming clayey soil highly
susceptible to sliding. Includes coves (U-shaped,
shallow valleys) containing thick layers of clayey
soil that are very susceptible to sliding where
excavation breaks continuity of slope and where
overloaded by artificial fill.

Information shown is intended as a
general guide to ground conditions as of
the date of field check. Additional
landslides and rockfalls should be anticipated
in all map units. The map unit depicts
the dominant condition in the area delineated
and variations in slope stability may occur
at any point in the unit. This map is suit-
able for general planning purposes and as a
supplement to more detailed studies for site
selection. The map cannot be used as a sub-
stitute for detailed geologic and engineering
investigations to establish design and
construction criteria of specific sites.
Some symbols may not appear on this map
because the description is applicable to a
series of maps.

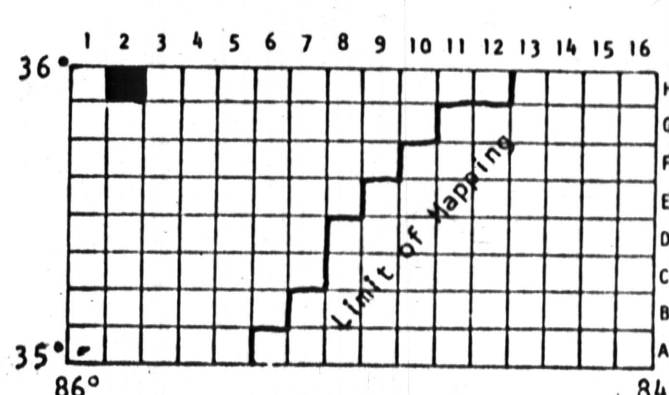
CHATTANOOGA 1° X 2° SHEET

The first six digits of the open file number designate the
specific 1:250,000 scale map sheet of which this quadrangle
is a part. The last two digits designate the position of the
quadrangle in a subdivision of the 1:250,000 scale map based
on rows and tiers shown in the diagram to the right. The
location of this quadrangle is shown by the black square.
